Environmental Studies No. 6

Sump Studies: I Terrain Disturbances

H.M. French,
Department of Geography and Regional Planning,
University of Ottawa.

Published under authority of the
Hon. J. Hugh Faulkner, Minister
of Indian and Northern Affairs Canada,
Ottawa, 1978.

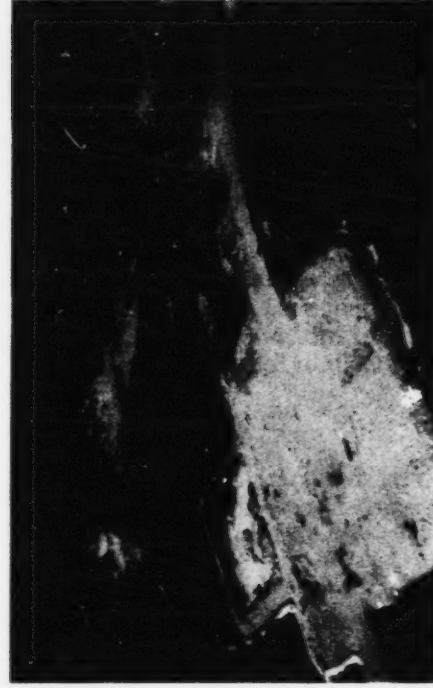
Fig. 7(d) Air view of Imperial Taglu F-43 wellsite, Mackenzie Delta, September 9, 1976.

Sump problems at all sites relate to a lack of infill material (Figure 7 c). This reflects the very high ice content of the underlying silts and the melt-out and volume loss which occurs during summer. The most apparent material deficiencies occur at Niglintgak M-19, a late summer/early winter operation drilled between June 1974 and January 1975, and Niglintgak H-30, where the sump remained open during the summer of 1973.
